Director, Operational Test and Evaluation

M109 Family of Vehicles, Paladin Integrated Management (PIM)

**Operational Assessment of the Initial Operational Test and
Evaluation**

January 2017

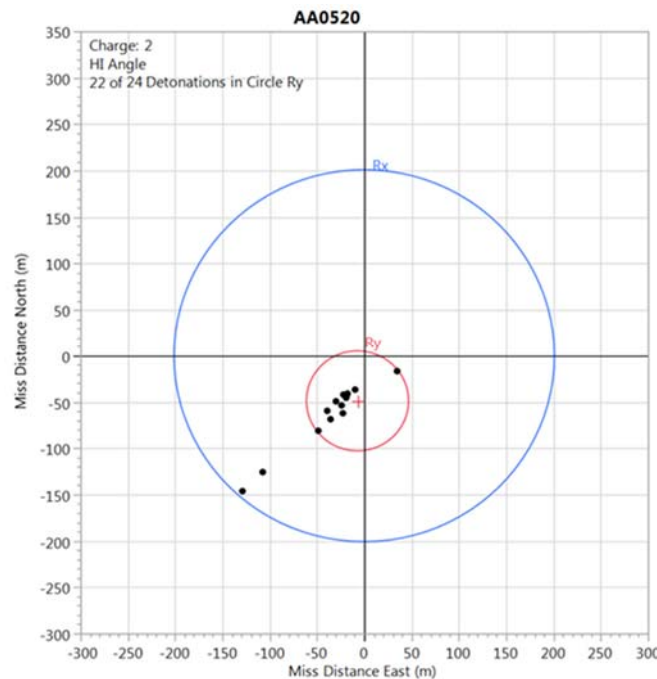
Figure 2-1. Example Graphical Accuracy Assessment for Mission AA0520

Figure 2-1 is an illustrated example of the mission-level scoring results for one IOT&E fire mission (labeled Fire Mission AA0520). Twenty-four projectiles were fired using charge 2 at high angle in this mission. From Table D-27 in TC 3-09.8, the radius of RX is 201 meters and the radius of RY is 54 meters. For the example IOT&E fire mission AA0520, 22 of 24 projectile impact points were inside circle RY and the mission was accurate and scored as a success.

Seventy-eight percent (62 of 80; 80 percent confidence interval from 70 percent to 83 percent) of M109A7 SPH fire missions in the IOT&E met this mission-level accuracy standard.⁷ By way of comparison with the legacy howitzers, the M109A6 SPH FOT&E test unit met mission-level accuracy standards in 62 percent (191 of 310; 80 percent confidence interval of 58 percent to 65 percent) of their fire missions. The M109A7 SPH-equipped unit demonstrated greater accuracy using the training standards metric than the M109A6 SPH-equipped FOT&E unit (p-value = 0.012).
